STREAM PASSAGE IMPROVEMENT FOR INFRASTRUCTURE, FISH PASSAGE, AND FLOOD MITIGATION

Melinda Bubier, EIT, Wetlands Mitigation Program
Shane Csiki, Ph.D., CFM, New Hampshire Geological Survey
New Hampshire Department of Environmental Services
March 24, 2017

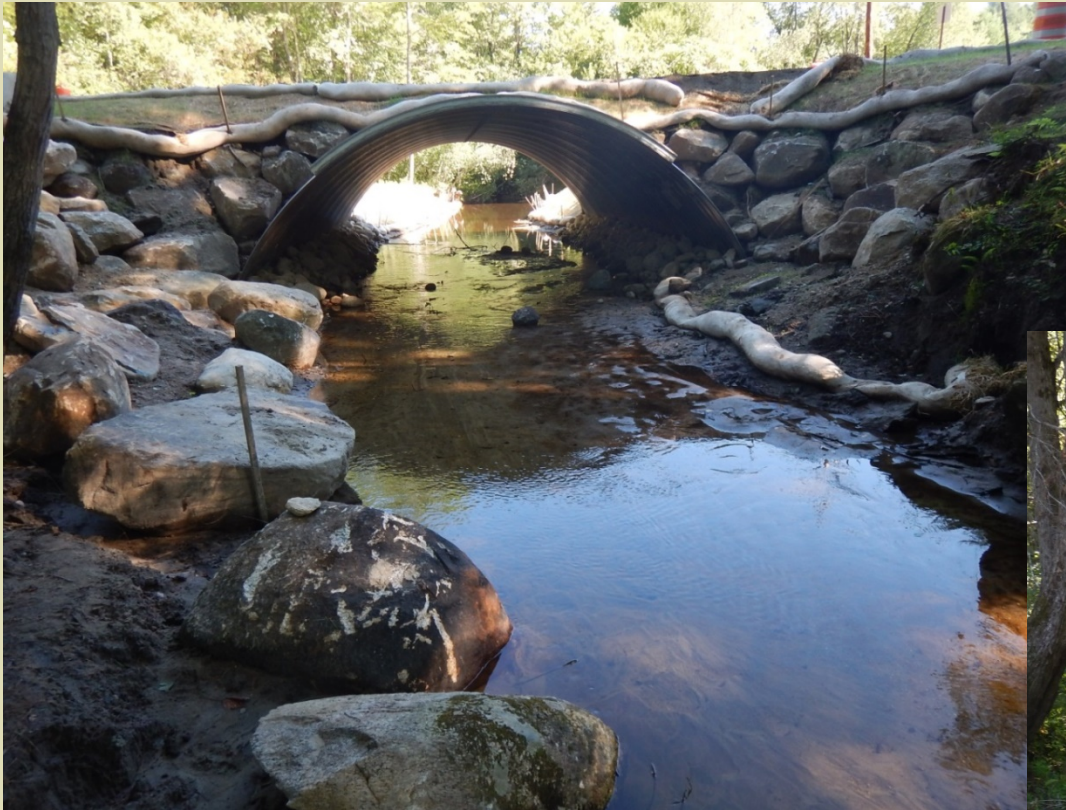
**Upstream (inlet)
side of culvert
August 19, 2016**

- **Install 23-foot wide open bottom arch**
- **Connection to approximately ten miles of upstream, barrier free, spawning and rearing aquatic habitat.**
- **Access to spawning habitat on approximately 6 smaller tributaries.**

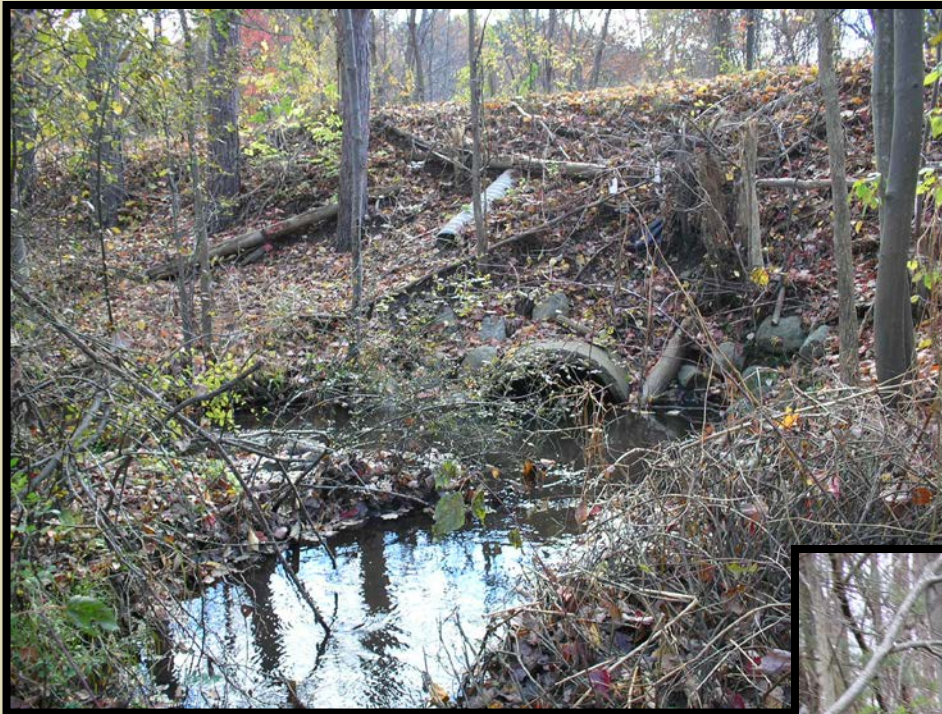
Left: Eastman Upstream 2014

Right: Eastman Downstream 2014

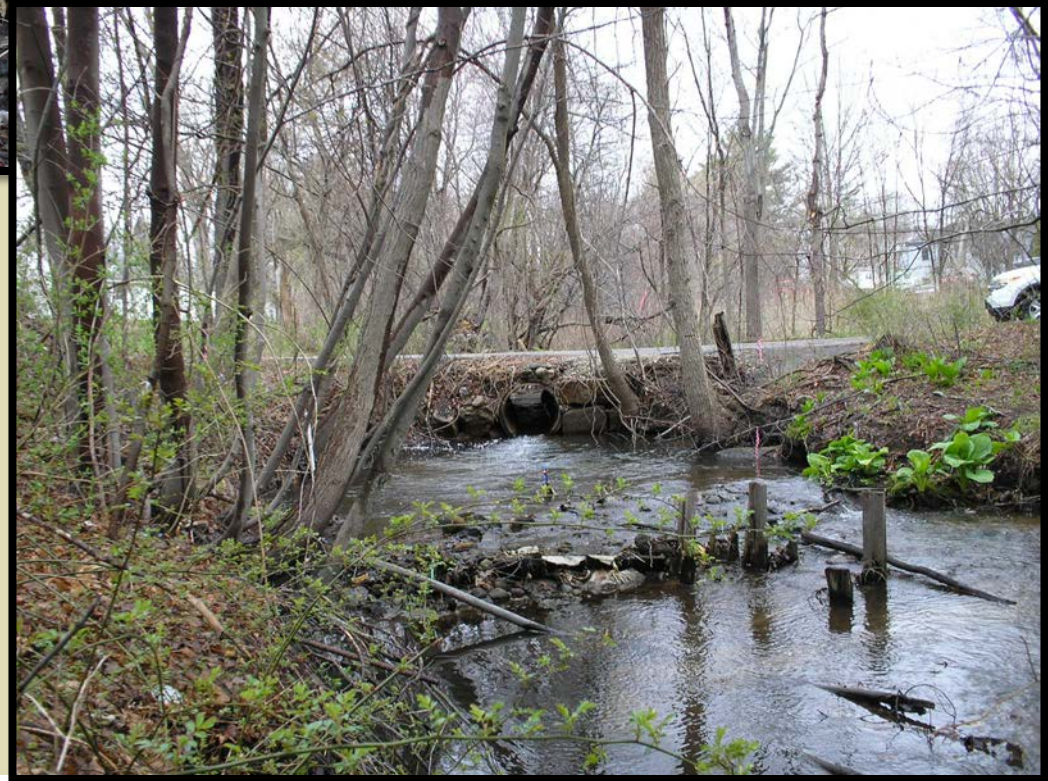
Aquatic Organism Screen = Reduced AOP

Geomorphic Compatibility Screen:

Eastman = Mostly Incompatible
Wathen = Partially Incompatible

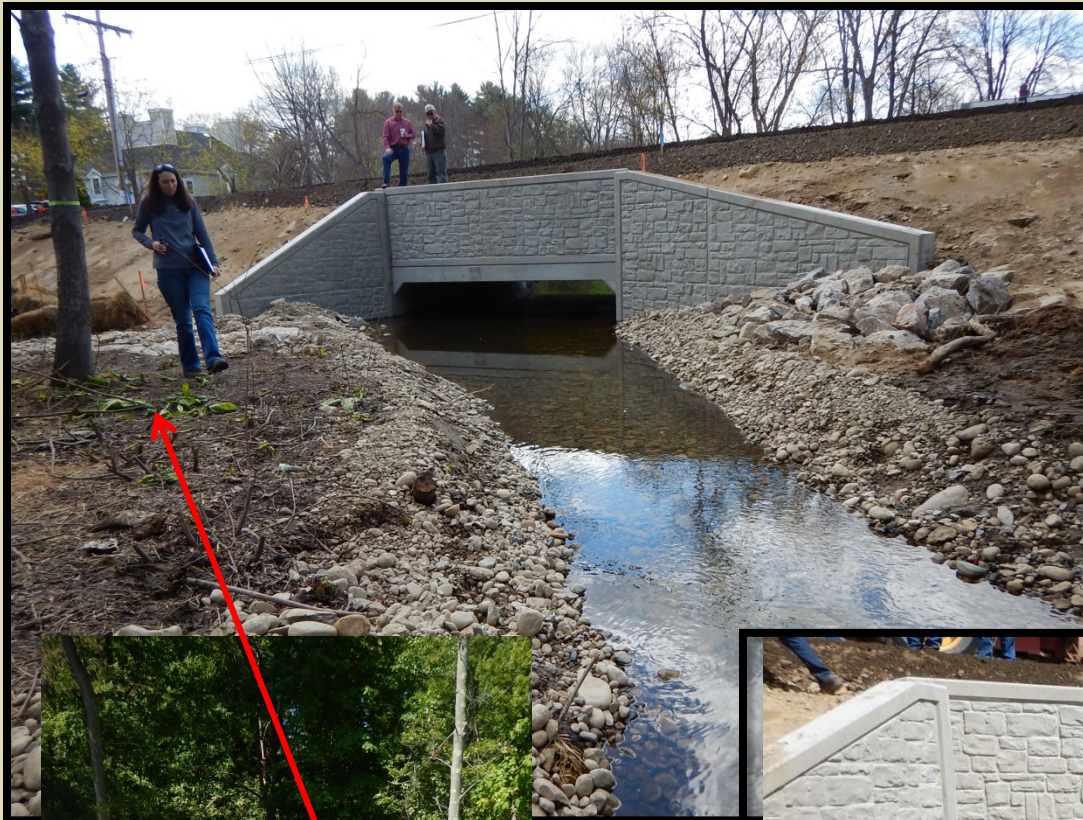
Completed 15' foot span

Left: Eastman Downstream
April 29, 2016

Below Eastman Upstream
April 29, 2016

Below Left: Eastman Upstream
August 16, 2016

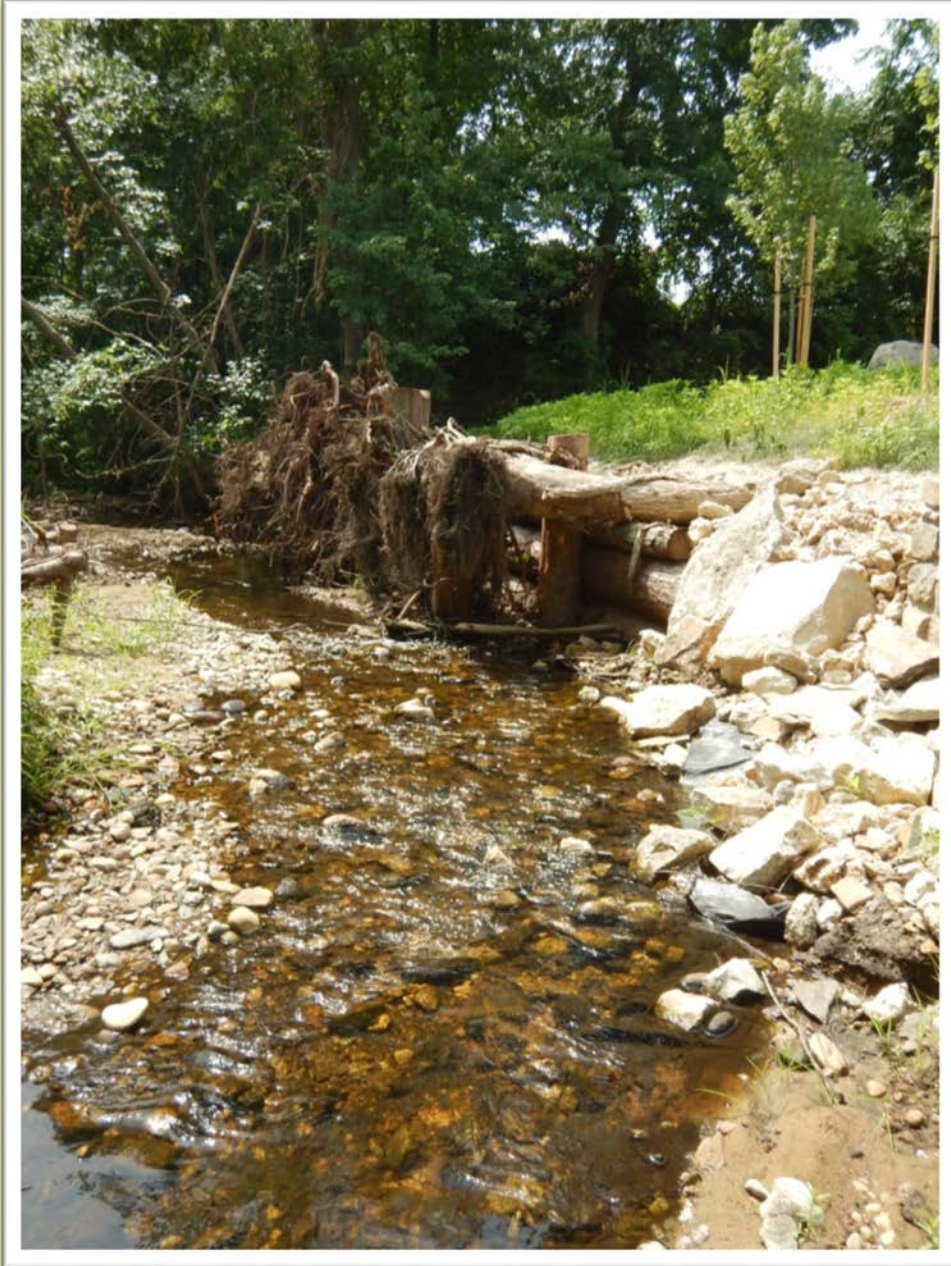
- Wathen “Inlet” July 2016
- Work overseen by John Fields
