Assessing Ecosystem Impacts from Road-Stream Crossings through Community Involvement

Road-Stream Crossing Assessments- describes the level of fragmentation within a watershed

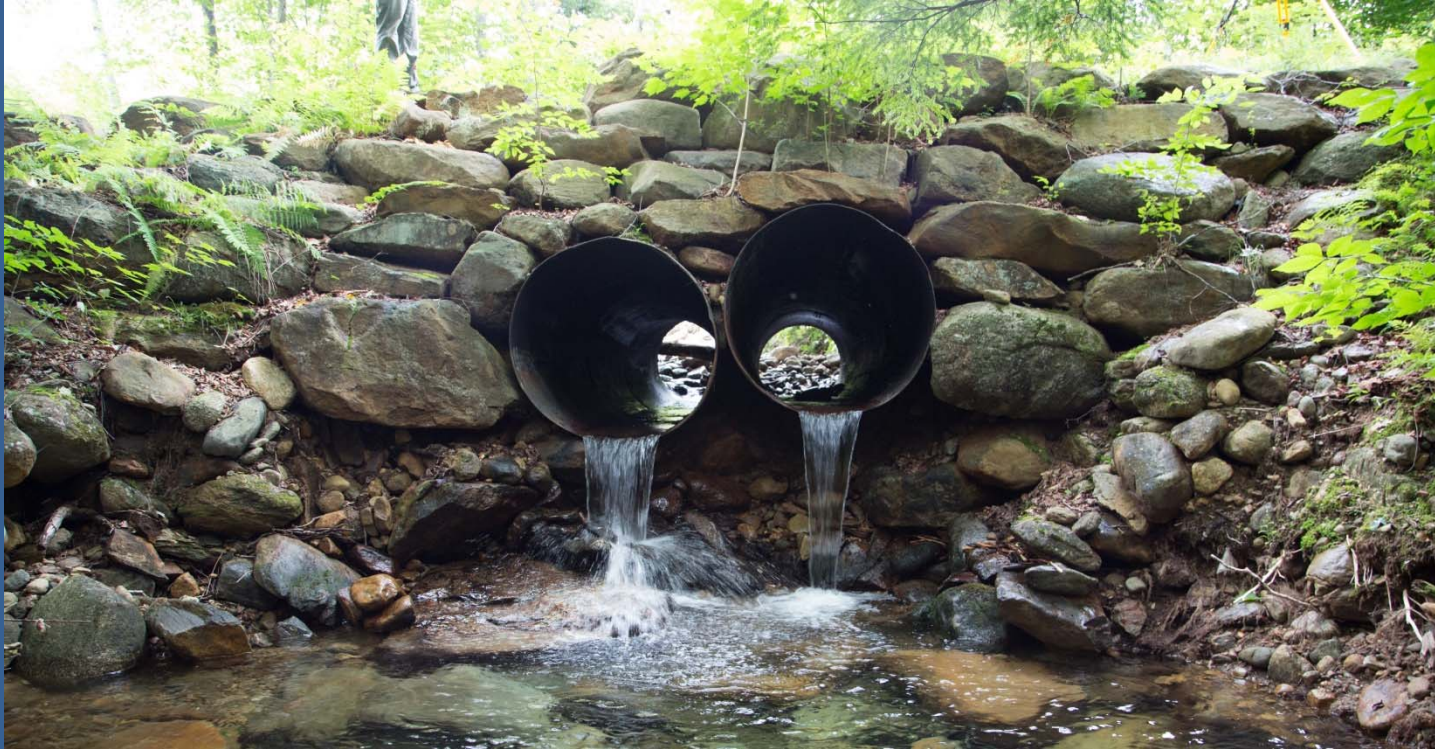
- Block fish migration
- Reduce opportunities to (re)colonize areas
- Alter natural erosion and sedimentation rates of a stream
- Shallow depths during low flow conditions/Amplified flows during flood events
- Alter physical stream channel features

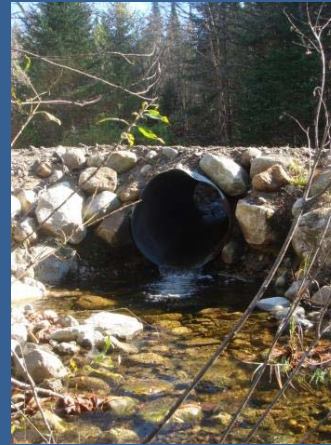
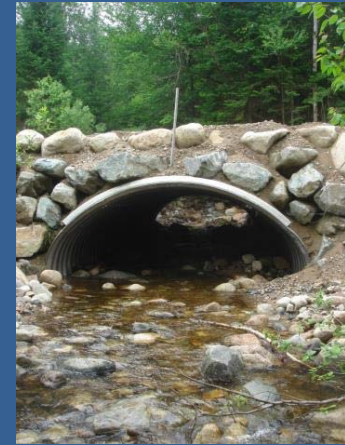
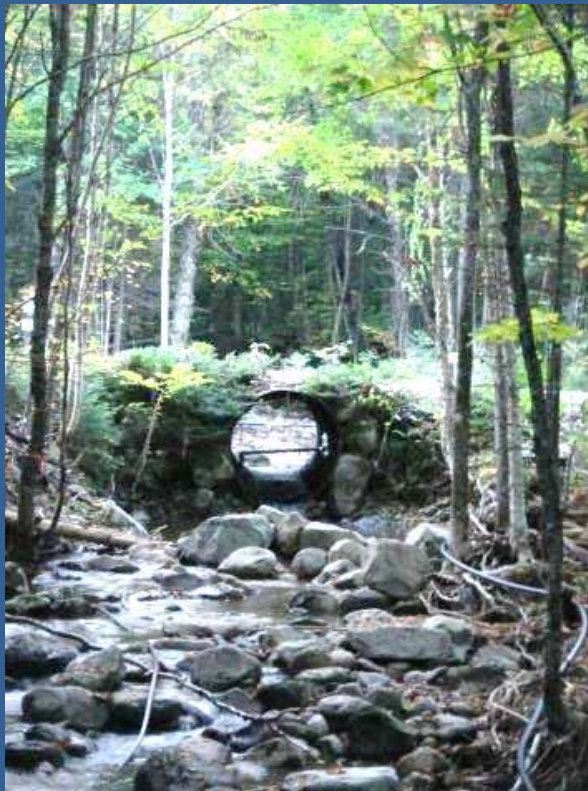
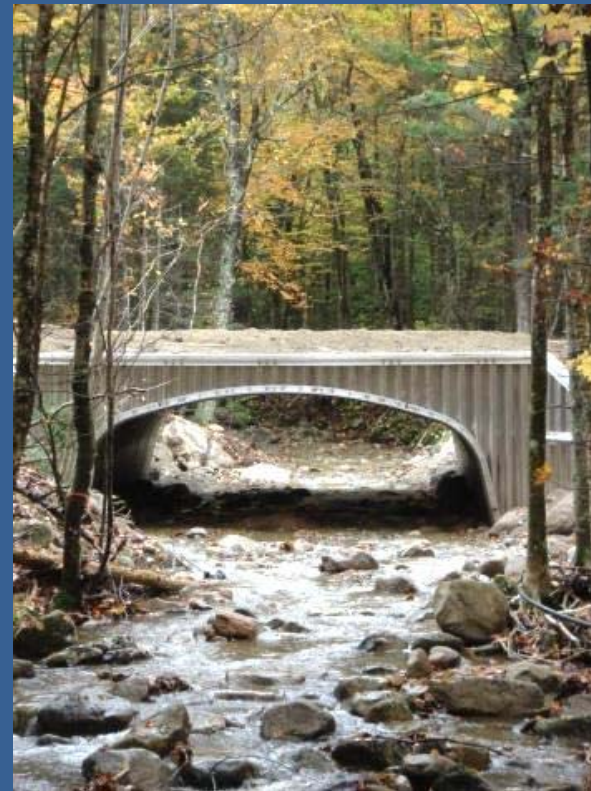
Features of a good stream crossing

- Natural streambed composition in structure
- No change in flow rate and depth
- Appropriately sized to accommodate a wide variety of flows

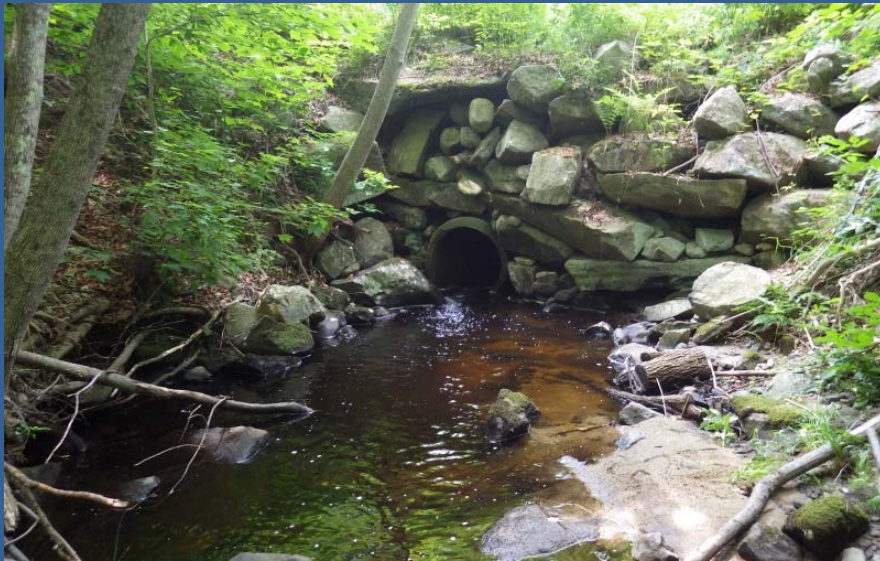
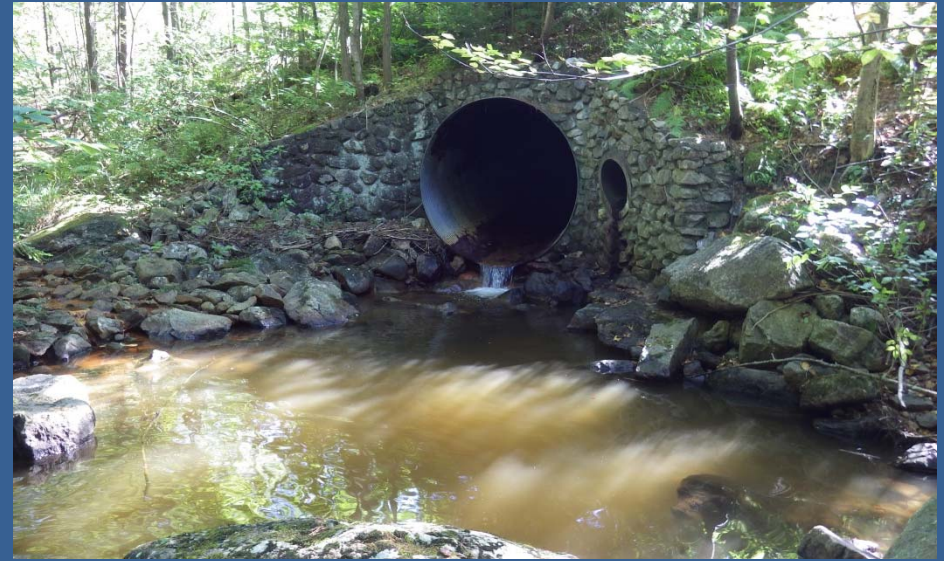
Warner River Watershed:	Structure Type:	Arch Structures:	6
		Bridges:	19
		Culverts:	91
	Condition:	Collapsing:	4.2%
		Eroding:	1.1%
		New:	20.0%
		Old:	66.3%
		Rusted:	8.4%

Average crossing structure width is only about half the bankfull width
A minimum width of 1.2 X bankfull width is recommended

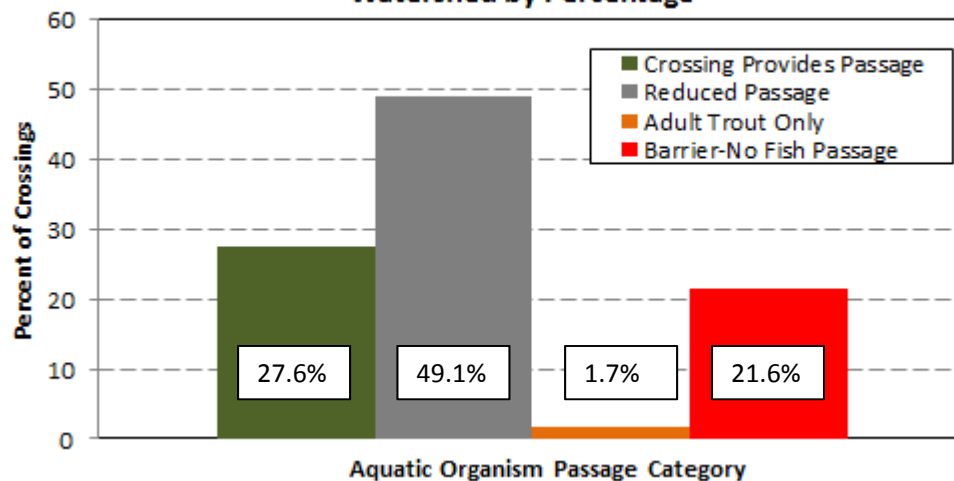
Variables Include:

- Outlet drop
- Presence of pool
- Pool entrance depth
- Water depth in culvert
- Substrate through structure
- Obstructions in structure

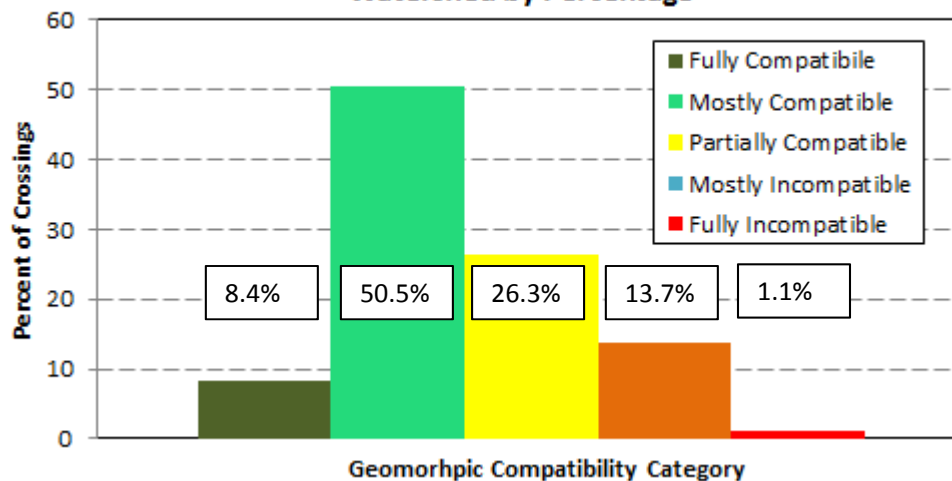
Variables Include:

- % Bankfull width
- Substrate continuity
- Slope
- Approach angle
- Bank erosion
